YOUR ONESURVEY
HOME REPORT

The Neuk
16a Grange Terrace
Bo'Ness
EH51 9DS

SINGLE SURVEY

Single Survey

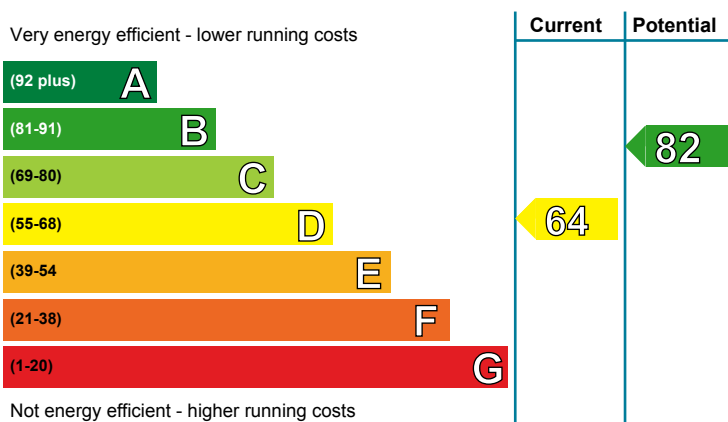
Energy Efficiency Rating

This graph shows the current efficiency of your home, taking into account both energy efficiency and fuel costs. The higher this rating, the lower your fuel bills are likely to be.

Your current rating is **band D (64)**. The average rating for EPCs in Scotland is **band D (61)**.

The potential rating shows the effect of undertaking all of the improvement measures listed within your recommendations report.
