YOUR ONESURVEY  
**HOME REPORT**

1 Brown Crescent  
Bathgate  
EH48 2XF

# SINGLE SURVEY

A report on the condition of the property, with categories  
being rated from 1 to 3.

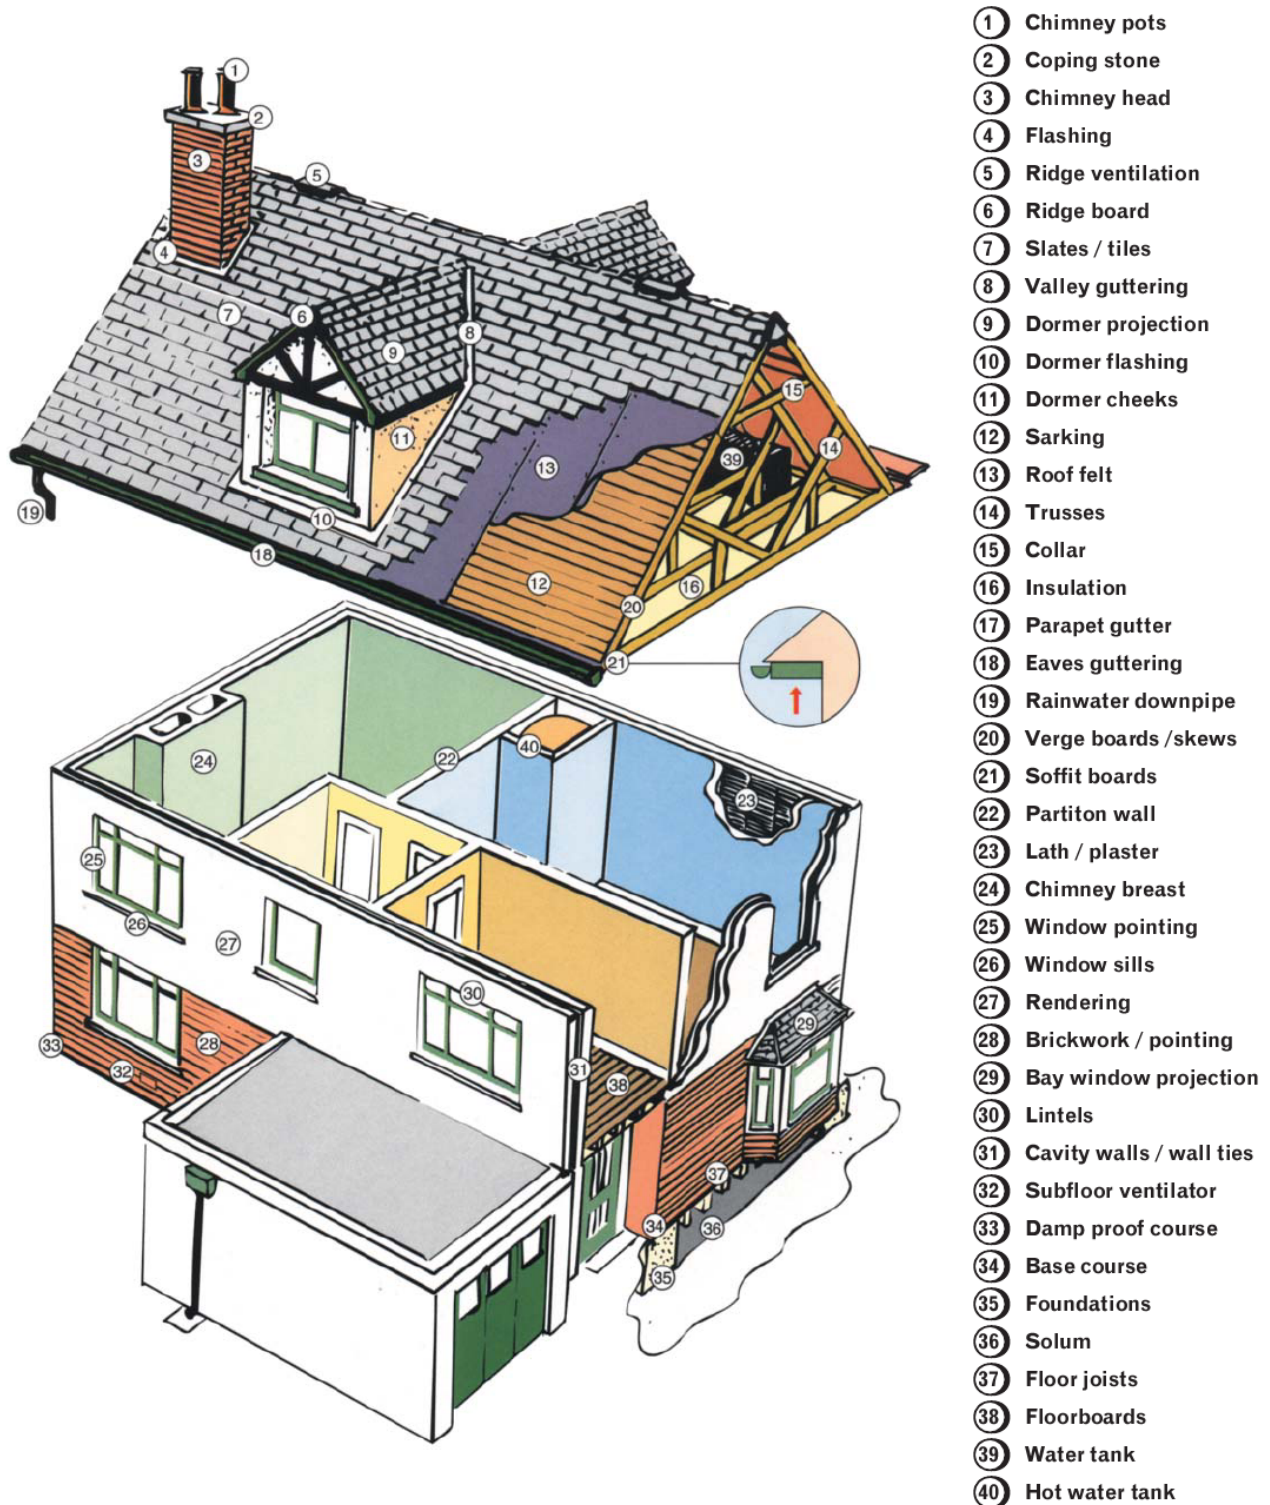
## Sectional Diagram showing elements of a typical house

Reference may be made in this report to some or all of the above component parts of the property. This diagram may assist you in locating and understanding these items.

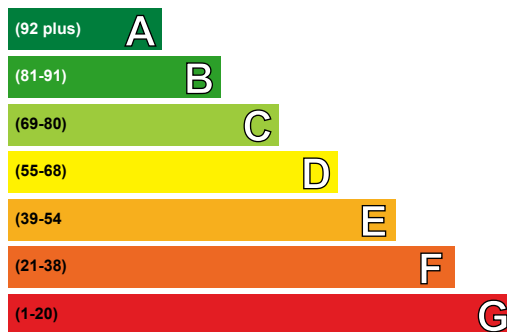
Very energy efficient - lower running costs

Not energy efficient - higher running costs

Current	Potential
75	75

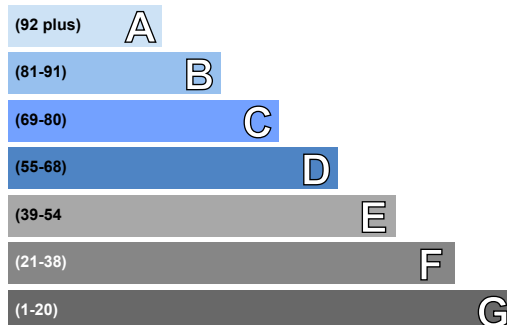
Very environmentally friendly - lower CO<sub>2</sub> emissions

Not environmentally friendly - higher CO<sub>2</sub> emissions

Current	Potential
73	73
