YOUR ONESURVEY
HOME REPORT

5
Kepscaith Road
Whitburn
EH47 8JB

HOME REPORT

Single Survey

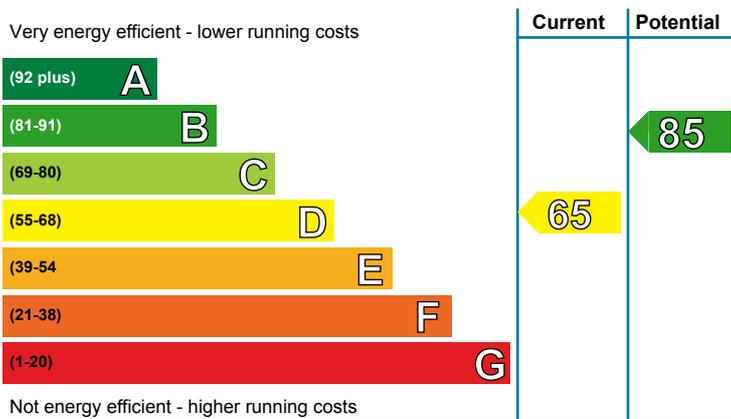
Energy Efficiency Rating

This graph shows the current efficiency of your home, taking into account both energy efficiency and fuel costs. The higher this rating, the lower your fuel bills are likely to be.

Your current rating is **band D (65)**. The average rating for EPCs in Scotland is **band D (61)**.

The potential rating shows the effect of undertaking all of the improvement measures listed within your recommendations report.

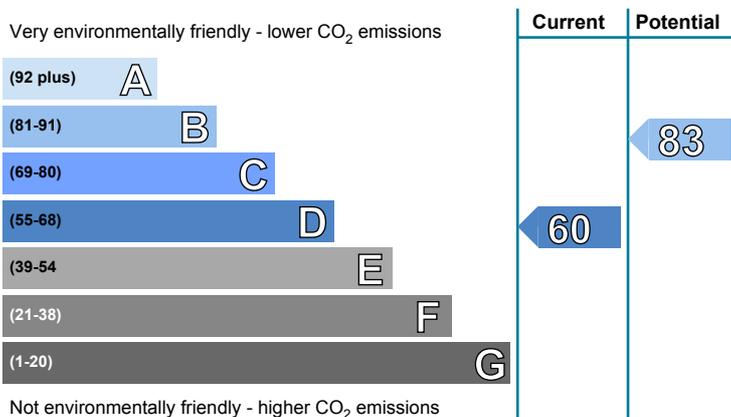
Environmental Impact (CO₂) Rating

This graph shows the effect of your home on the environment in terms of carbon dioxide (CO₂) emissions. The higher the rating, the less impact it has on the environment.
