YOUR ONESURVEY
HOME REPORT

28 Cadzow Avenue
Bo'Ness
EH51 9BT

HOME REPORT

SINGLE SURVEY

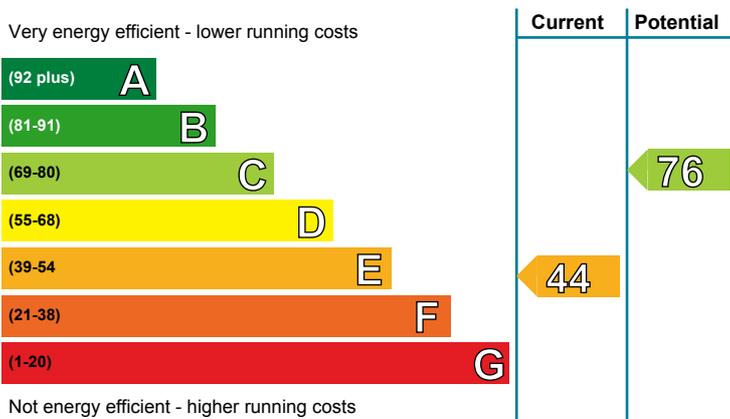
Energy Efficiency Rating

This graph shows the current efficiency of your home, taking into account both energy efficiency and fuel costs. The higher this rating, the lower your fuel bills are likely to be.

Your current rating is **band E (44)**. The average rating for EPCs in Scotland is **band D (61)**.

The potential rating shows the effect of undertaking all of the improvement measures listed within your recommendations report.
