YOUR ONESURVEY
HOME REPORT

140 West Main Street
Armadale, Bathgate
EH48 3HX

SINGLE SURVEY

A report on the condition of the property, with categories being rated from 1 to 3.

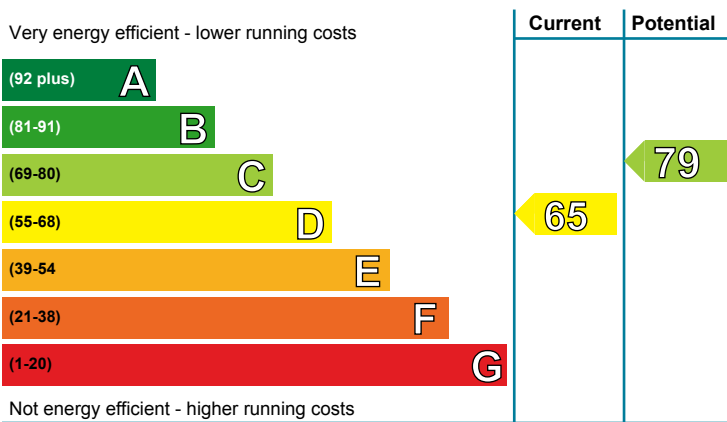
Energy Efficiency Rating

This graph shows the current efficiency of your home, taking into account both energy efficiency and fuel costs. The higher this rating, the lower your fuel bills are likely to be.

Your current rating is **band D (65)**. The average rating for EPCs in Scotland is **band D (61)**.

The potential rating shows the effect of undertaking all of the improvement measures listed within your recommendations report.
