# YOUR ONESURVEY HOME REPORT

22 Glenwood Drive Armadale, Bathgate EH48 3TU

# SINGLE Survey

# Single Survey

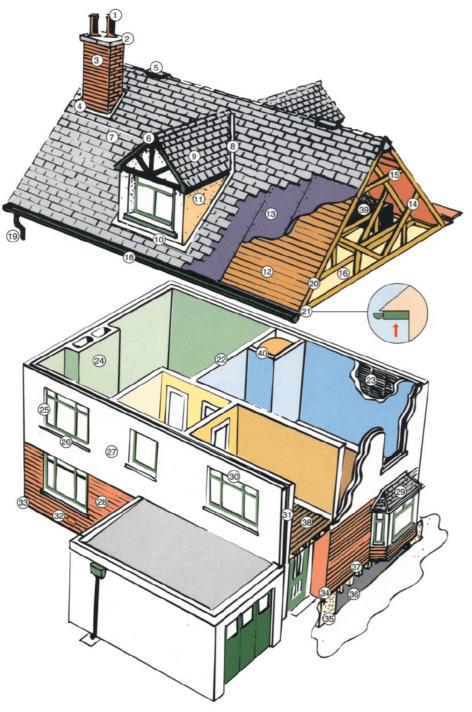
### Sectional Diagram showing elements of a typical house

Coping stone (2) Chimney head (3) Flashing (4)**Ridge ventilation** (5) Ridge board (6) Slates / tiles ി Valley guttering (8) (9) Dormer projection (10) Dormer flashing (11) Dormer cheeks (12) Sarking (13) Roof felt (14) Trusses (15) Collar (16) Insulation (17) Parapet gutter (18) Eaves guttering (19) Rainwater downpipe Verge boards/skews 20 Soffit boards (21) Partiton wall (22) Lath / plaster (23) (24) Chimney breast Window pointing (25) Window sills (26) Rendering (27) (28) Brickwork / pointing (29) Bay window projection (30) Lintels (31) Cavity walls / wall ties (32) Subfloor ventilator 33) Damp proof course Base course (34) Foundations (35) Solum (36) Floor joists (37) Floorboards 38) Water tank (39)
