25 HILLSIDE DRIVE
BLACKRIDGE
BATHGATE
EH48 3SL

Home Report

25 HILLSIDE DRIVE, BLACKRIDGE, BATHGATE, EH48 3SL

Dwelling type:	End-terrace house	Reference number:	7519-4620-4009-0080-3226
Date of assessment:	20 October 2021	Type of assessment:	RdSAP, existing dwelling
Date of certificate:	25 November 2021	Approved Organisation:	Elmhurst
Total floor area:	75 m ²	Main heating and fuel:	Boiler and radiators, mains gas
Primary Energy Indicator:	384 kWh/m ² /year

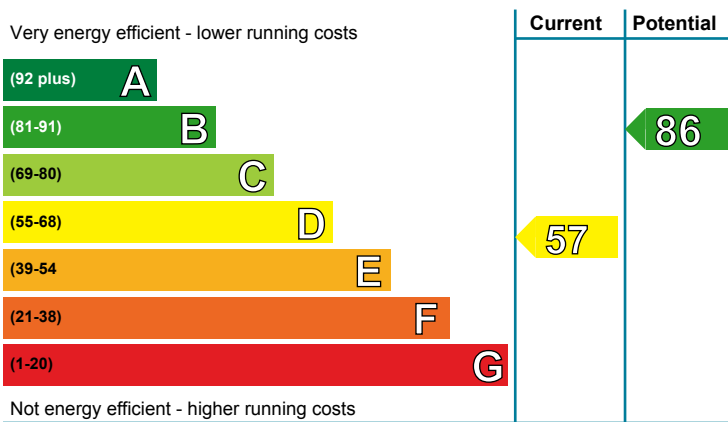
Energy Efficiency Rating

This graph shows the current efficiency of your home, taking into account both energy efficiency and fuel costs. The higher this rating, the lower your fuel bills are likely to be.

Your current rating is **band D (57)**. The average rating for EPCs in Scotland is **band D (61)**.

The potential rating shows the effect of undertaking all of the improvement measures listed within your recommendations report.

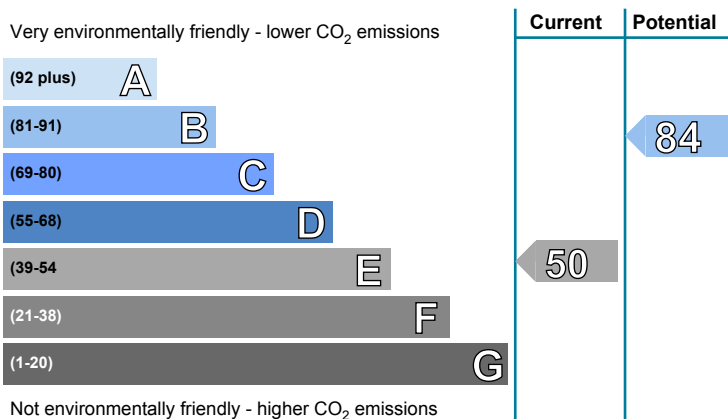
Environmental Impact (CO₂) Rating

This graph shows the effect of your home on the environment in terms of carbon dioxide (CO₂) emissions. The higher the rating, the less impact it has on the environment.

Your current rating is **band E (50)**. The average rating for EPCs in Scotland is **band D (59)**.

The potential rating shows the effect of undertaking all of the improvement measures listed within your recommendations report.
