Single Survey

Property address	67 Temple Avenue, Bathville, BATHGATE, EH48 2LS
-------------------------	--

Date of inspection	9th February 2023
---------------------------	-------------------

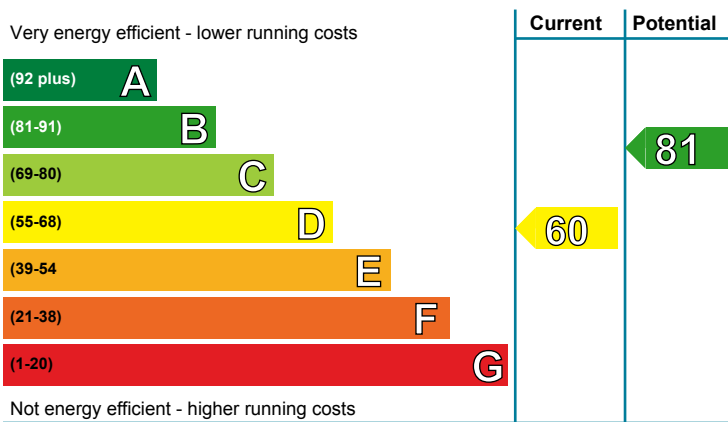
Energy Efficiency Rating

This graph shows the current efficiency of your home, taking into account both energy efficiency and fuel costs. The higher this rating, the lower your fuel bills are likely to be.

Your current rating is **band D (60)**. The average rating for EPCs in Scotland is **band D (61)**.

The potential rating shows the effect of undertaking all of the improvement measures listed within your recommendations report.

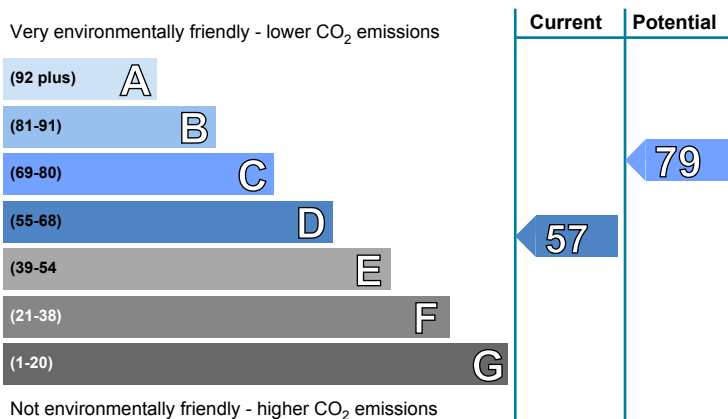
Environmental Impact (CO₂) Rating

This graph shows the effect of your home on the environment in terms of carbon dioxide (CO₂) emissions. The higher the rating, the less impact it has on the environment.

The potential rating shows the effect of undertaking all of the improvement measures listed within your recommendations report.

The average Scottish household produces about 6 tonnes of carbon dioxide every year. Based on this assessment, heating and lighting this home currently produces approximately 4.6 tonnes of carbon dioxide every year. Adopting recommendations in this report can reduce emissions and protect the environment. If you were to install all of these recommendations this could reduce emissions by 2.2 tonnes per year. You could reduce emissions even more by switching to renewable energy sources.
